ARMY ENGINEER DISTRICT PHILADELPHIA PA
NATIONAL DAM SAFETY PROGRAM. SILVER LAKE DAM. DE0031. DELAWARE --ETC(U)
JAN 78 F W VINCI

14. MONITORING AGENCY NAME & ADDRESS (if different from Controlling Office) National Dam Safety Program, Silver Lake Dam, DE0031. Delaware River Basin, St. Jones River, Kent County, Dover Delaware. Phase I Inspection Report.	12. REPORT DATE 11 January 1978

PHASE ONE
NATIONAL DAM SAFETY PROGRAM
SILVER LAKE DAM
ST. JONES RIVER, DOVER, DELAWARE

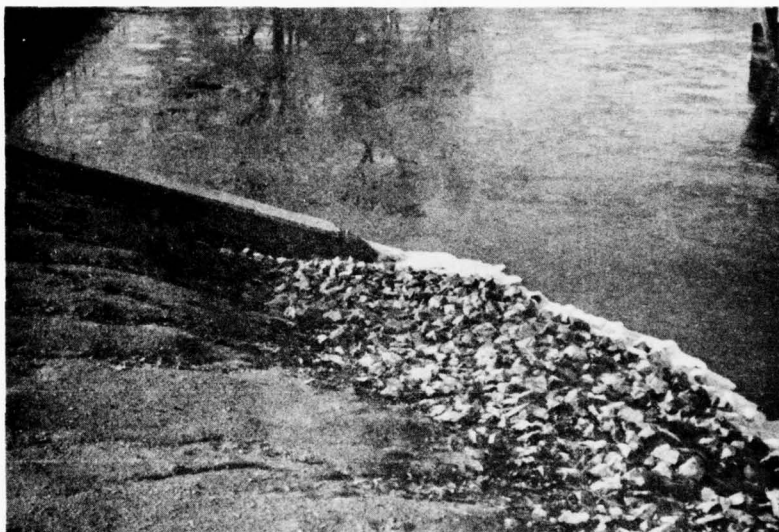
(3) Sloughing or erosion of embankment and abutment slopes: Sloughing was noted along the upstream embankment slope immediately left of the overflow structure. The sloughing appears to be the result of wave action; maintenance personnel attempted to alleviate the erosive action by placing 4-inch nominal ballast stone in the area. Stone appears unsatisfactory; see comment 6b (4) concerning the stone.

(2) Approach channel (concrete): The approach end of the left abutment overflow structure wall shows evidence of deteriorated concrete at the fluctuating freeze-thaw reservoir pool elevation. The right abutment wall approach end does not show this condition.

1. 13 Dec 77. Upstream embankment slope behind overflow structure left abutment wall. Note sloughing of embankment, 4" remedial stone, and deteriorating concrete at freeze-thaw line.

RIPRAP FAILURES	Stone protection along left upstream slope appears inadequate to prevent wave erosion.	Recommend formal riprap protection at erosion location; minimum 12-inch thickness of well graded stone and 6-inch filter blanket.

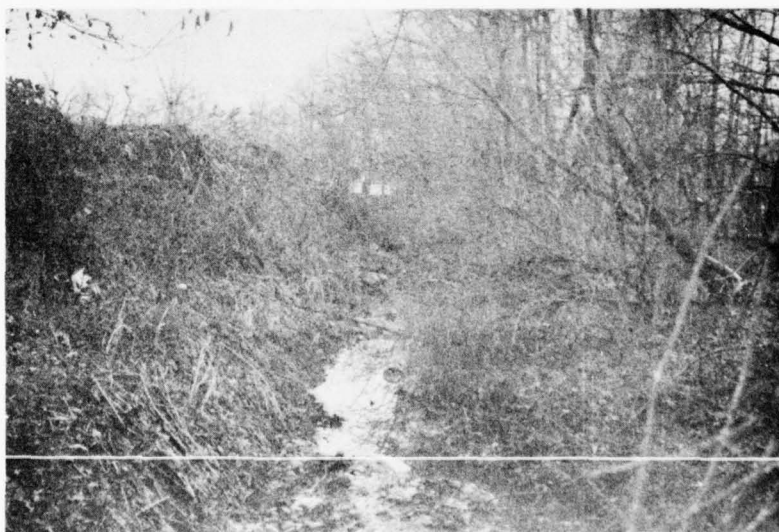
(7) Seepage: Seepage through the right embankment area was noted discharging into a storm water drainage swale approximately 400 feet downstream from the dam centerline. Invert elevation of the drainage swale is approximately 11 feet below normal pool elevation. No material transport was evident at the seepage locations and the seepage quantity does not appear of major significance although flow readings were not obtained or available.

2. 13 Dec 77. Downstream right abutment drainage swale, looking southeast toward confluence with St. Jones River.

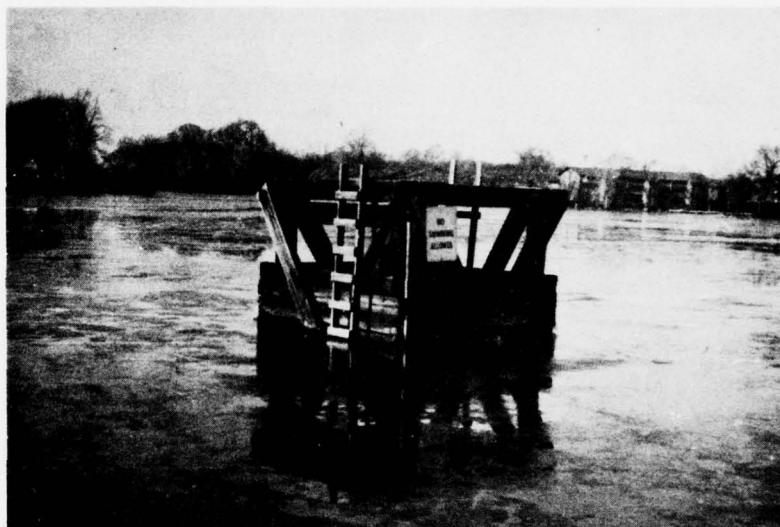
3. 13 Dec 77. View of sluice gate operating platform. Photo from left abutment area looking north toward upstream reservoir area.

EMERGENCY GATE	Sluice gate and operating platform not examined due to reservoir pool elevation; platform accessible only by boat.	Recommend close inspection of platform and sluice gate by owner representatives during next drawdown; diver can perform under- water inspection

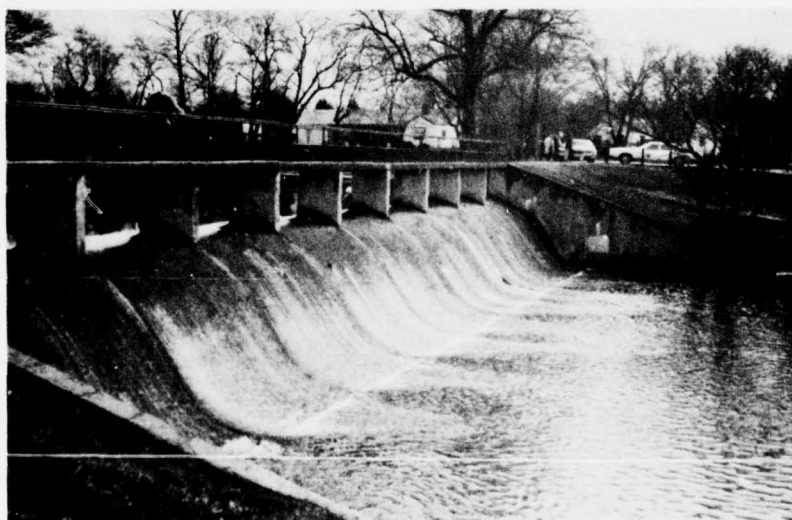
4. 13 Dec 77. Overview of concrete gravity overflow structure, looking east from right abutment wall toward left abutment wall.

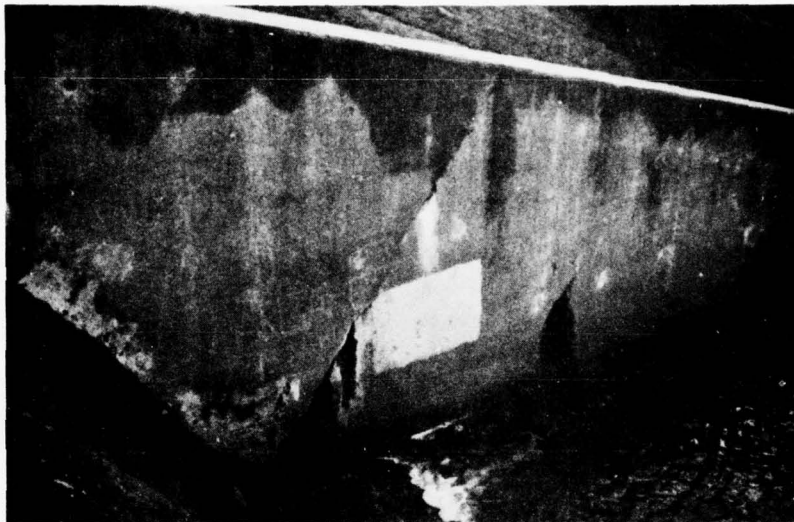
5. 13 Dec 77. Close view of overflow structure left abutment wall showing diagonal cracking with minor leakage, looking southeast from walkway.

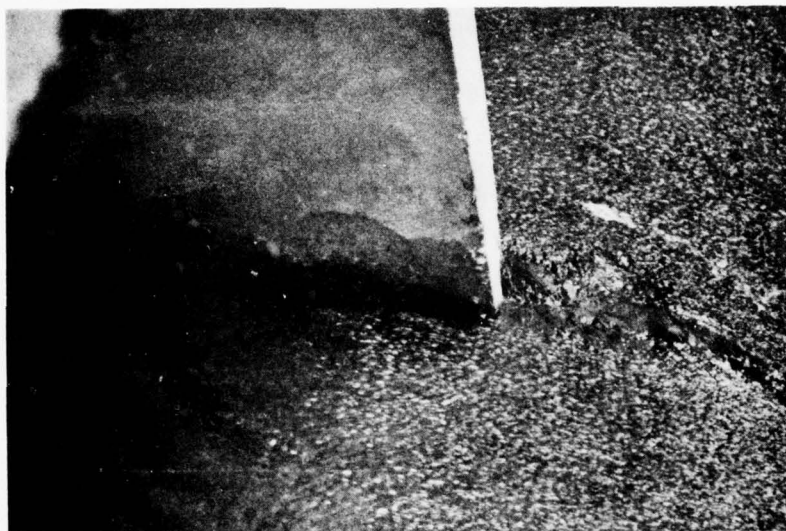
7. 13 Dec 77. Spalled concrete at pedestal/ogee crest construction joint.

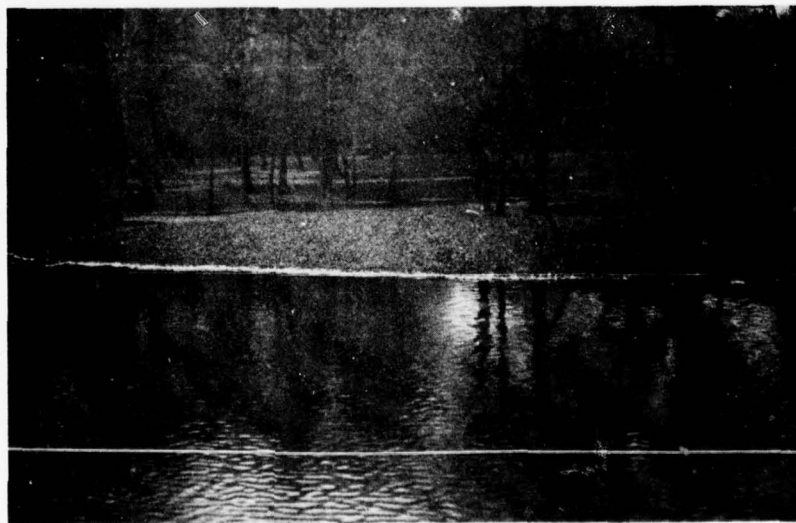
(6) Junction of embankment and abutment, spillway and dam: Erosion was noted adjacent to the overflow structures-embankment junction. It appears that the unvegetated embankment material behind the walls has been eroded due to normal rainfall runoff. No visual evidence of erosion or sloughing was noted at the embankment/abutment junctions.

8. 13 Dec 77. Downstream right bank erosion area and 4" stone remedial measures.
